## **Damage Assessment: Beit Hanoun Area**

**28 DECEMBER 2005**

## **Damage assessment report: Beit Hanoun area - 28 December 2005**

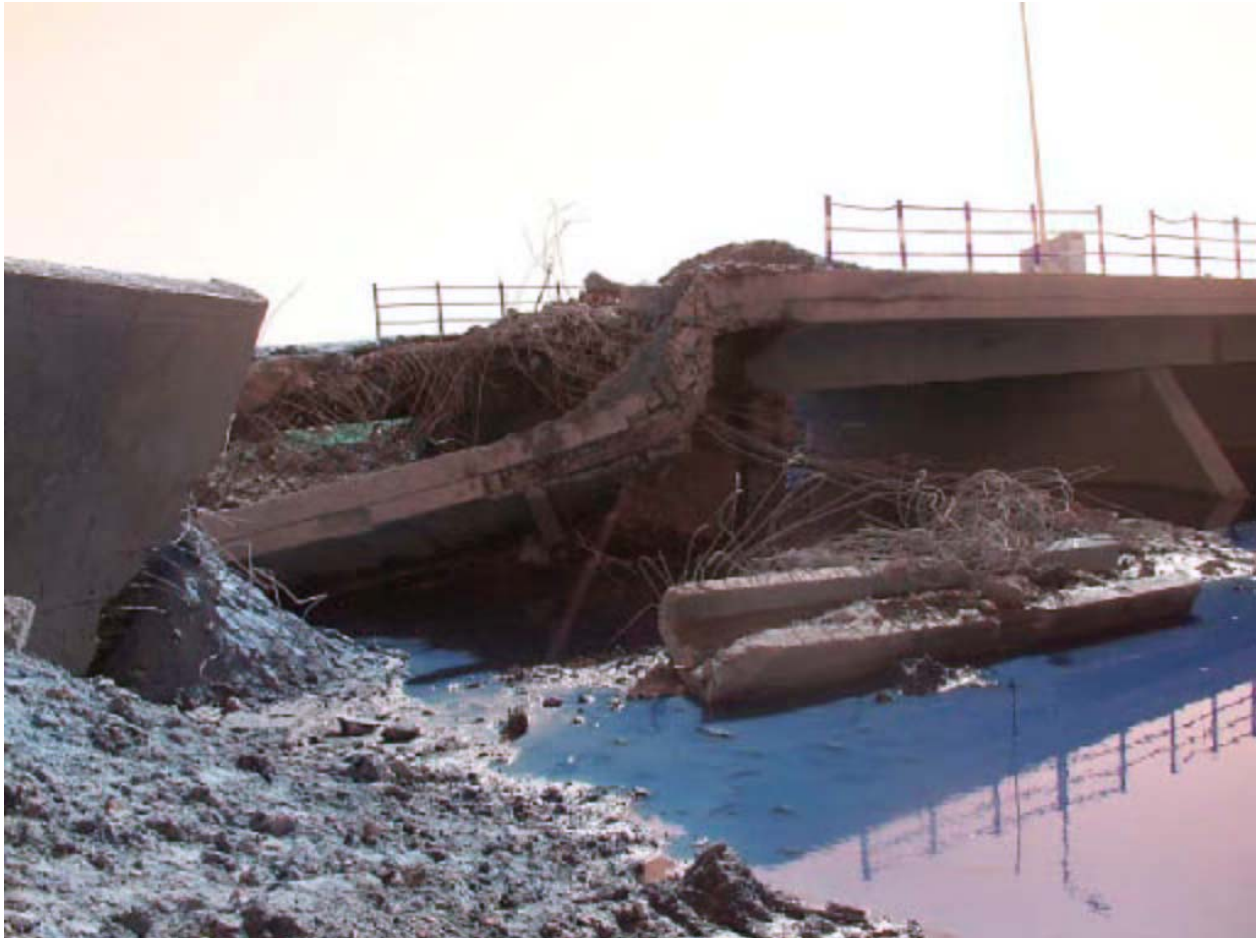
**El Seka Bridge**  
**Date of damage 27-28/12/2005**

- The northern part of the Bridge, the third section of it, is totally damaged
- The bridge cannot be rehabilitated and a new structure will have to be built.
- The construction of the bridge had a cost of 230,000 US\$ according to information from the Beit Hanoun Municipality (The bridge was funded by USAID).
- The road to the north of the bridge is severely damaged; approximately 200m<sup>2</sup>
- Three houses located to the west of the bridge have been evacuated.
- Many olives trees nearby have been burned due to the impact of the air strike.

The northern section of the bridge has been totally damaged by 16 missiles. IMG suggests a detailed technical examination of the remaining bridge to decide whether it can be rehabilitated. El Seka Bridge was funded by USAID

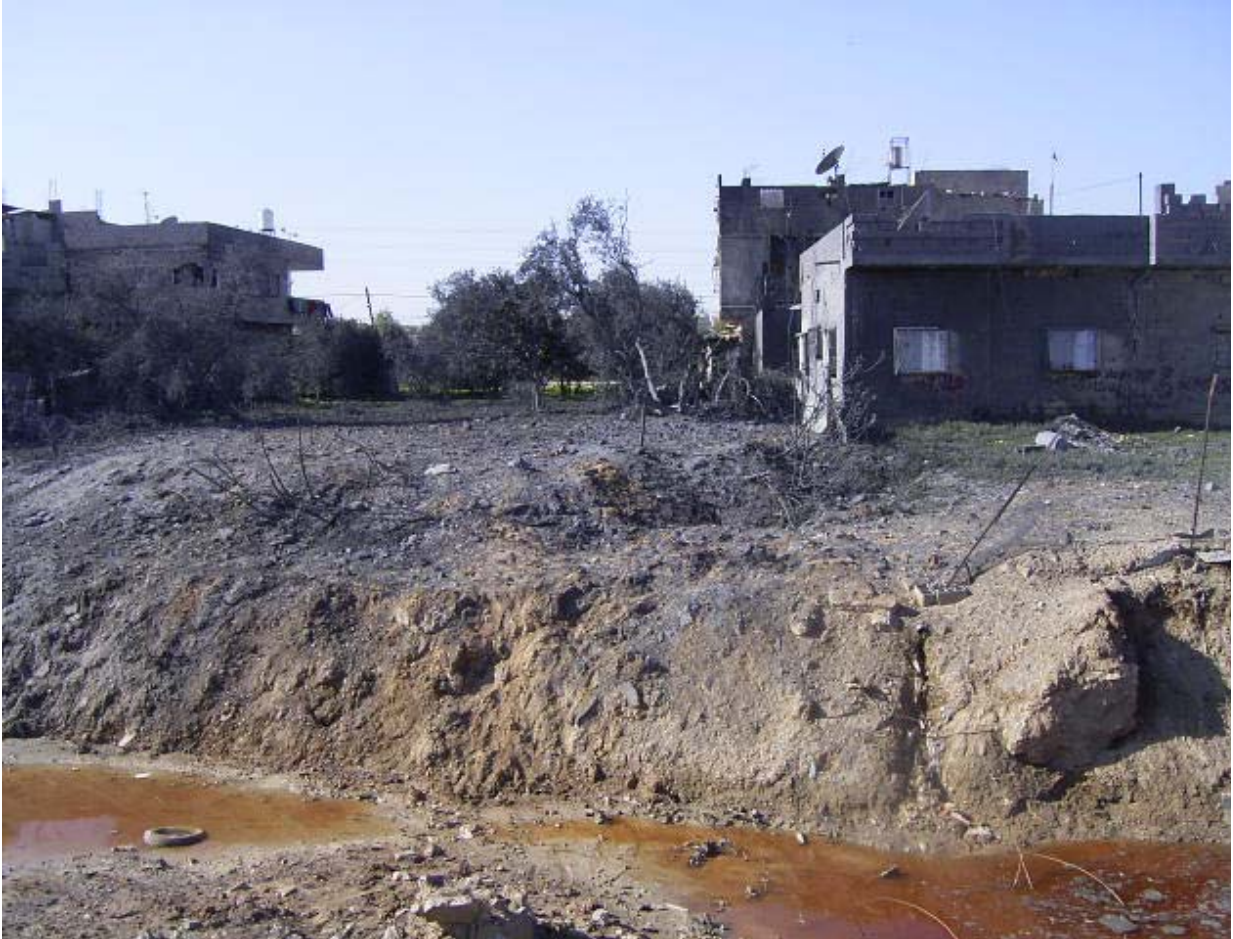
**El Seka Bridge**  
**Date of damage 27-28/12/2005**

Evacuated houses to the west of the El Seka Bridge

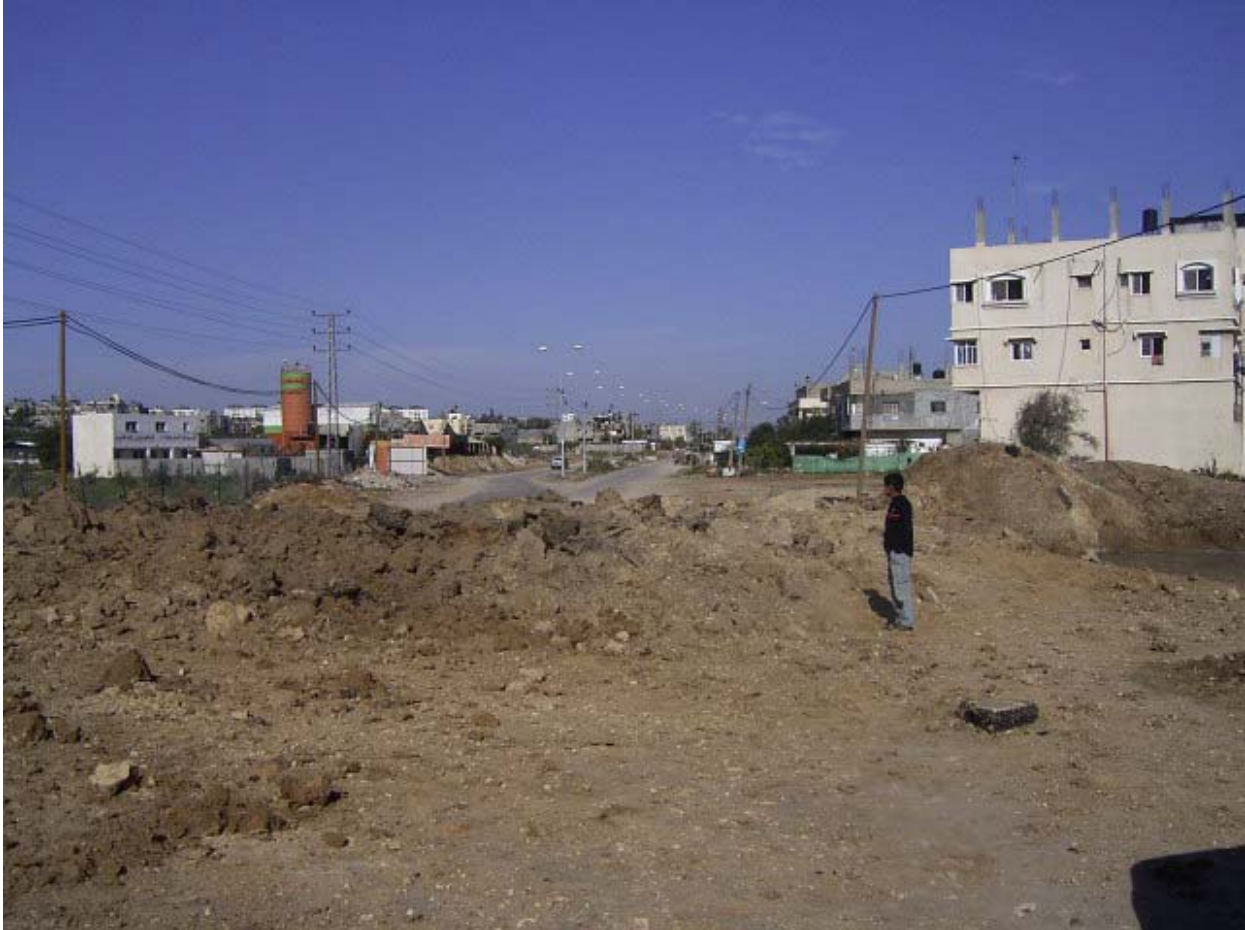
**Saleh El Din Road**  
**Date of damage 27-28/12/2005**

- The air strike created a hole in the road located to the northwest of El Seka Bridge with an area of 20m x 20 m and 5m depth.

View of Saleh El Din Road in the direction of Erez – northwest of El Seka Bridge (located to the right but out of the picture). The damaged area is of approximately 20m x 20m with a 5m deep hole.

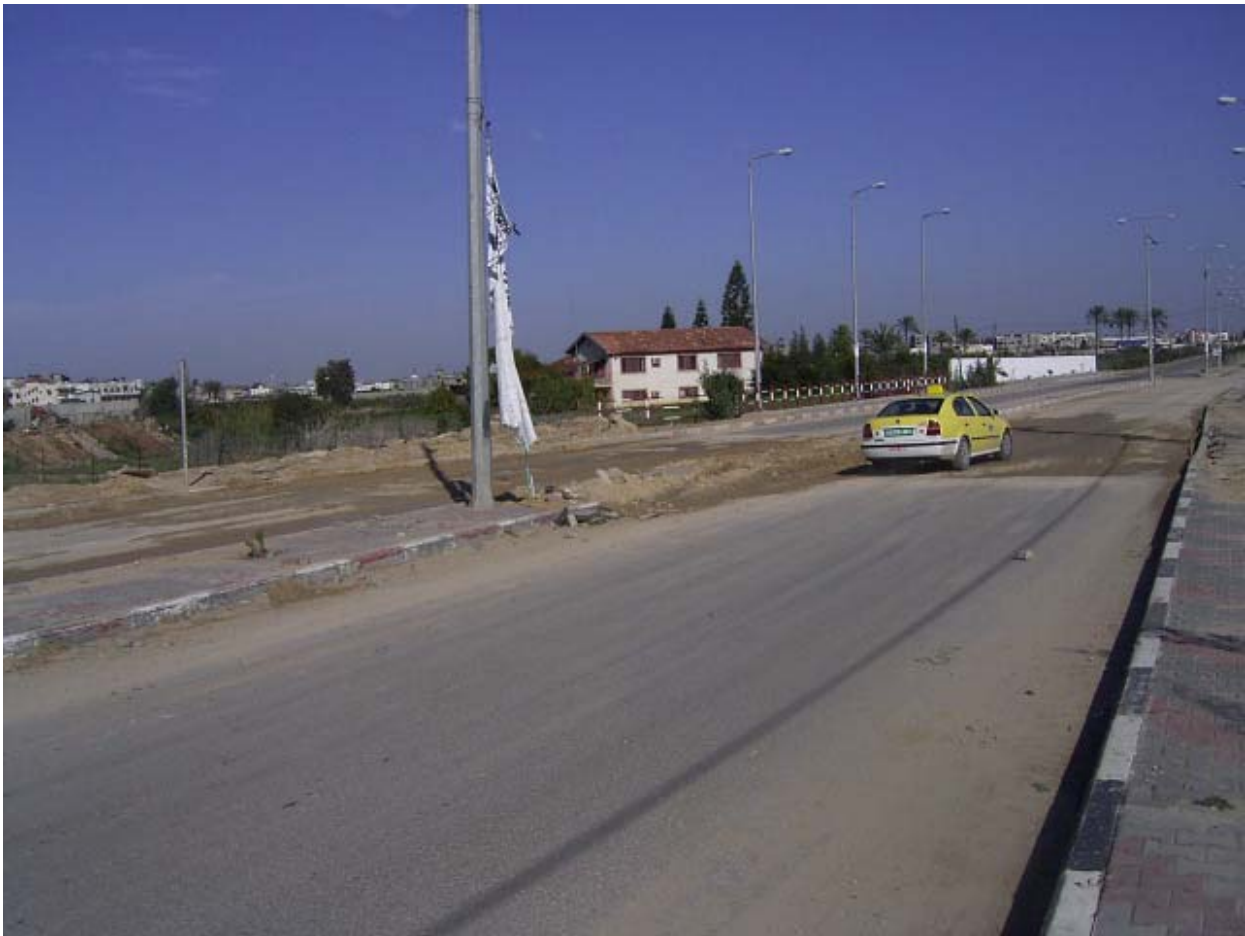
**The Main Entrance Bridge to Beit Hanoun (funded by EC)**  
**Date 28/12/2005**

- The bridge itself suffered no damages during the incursion of 27/28 December
- However, during a previous attack (See report 18 December 05) Israeli missiles struck the road paid by EC, just south of the bridge, making a hole This hole has been filled up with Kurkar –as a temporary solution- to make the road accessible for vehicles to pass in and out of Beit Hanoun from the south.

View towards Beit Hanoun.

The IAF attack the 14-15 December produced as a result two big holes in the road just south of the bridge. The holes have been filled up with kurkar material in order to make the road accessible for vehicles to pass in and out of Beit Hanoun.
